# Intel<sup>®</sup> Xeon<sup>®</sup> E3-1200 v6 Processor Family

**Specification Update**

**Revision 024**

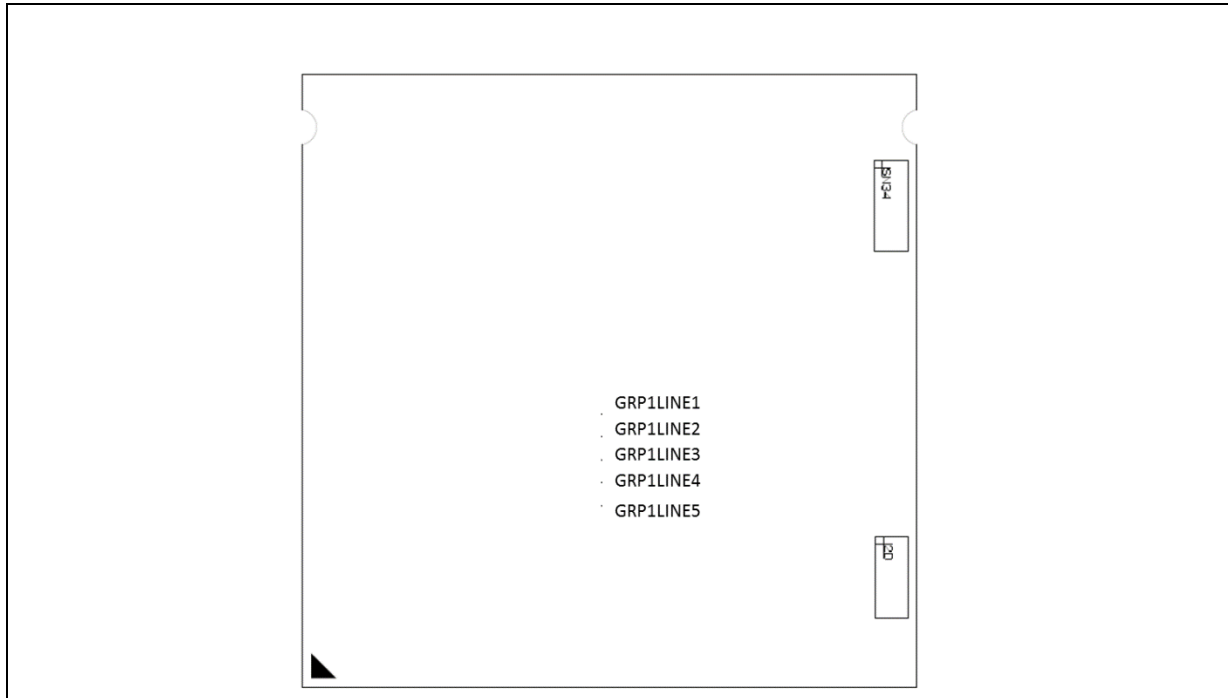
Figure 1. Land Grid Array (LGA) Top-Side Markings

Pin Count: 1151

Package Size: 37.5 mm x 37.5 mm
